Flood Control Project Maintenance
2014 Structure Summary Report
Overall Unit and Item Ratings

Lower San Joaquin Levee District

Ash Slough Drop Structure No. 1

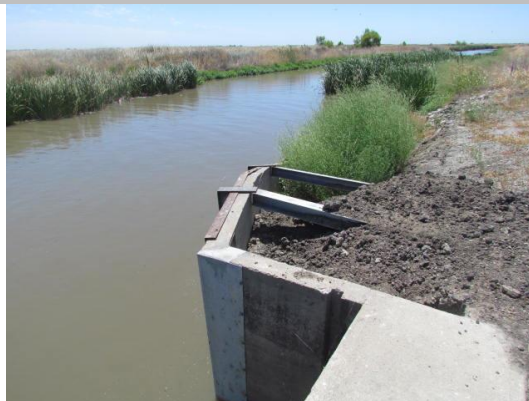
Photo 2 of 2 : ST_2014_NA0010_49_22_20140710_00012.jpg

LM Start	0.00	Rating **	M	Issue No.	22 (cont)	
LM End	0.00	Issue Type +	Ma	Location *		
Category	Structures & Concrete Lined Channels			GPS Latitude/Longitude		
				Start		End
Item	Monolith Joints			37.219788 °	37.219788 °	
				-120.698058 °	-120.698058 °	
DWR ID	DWR_NA0010_49_t_2012_22					
Action/Comments						
Inspector Comments: Left & right wing walls joints have been repaired, but still unstable.

Looking at repaired left wing wall on upstream side of structure. Summer 2012

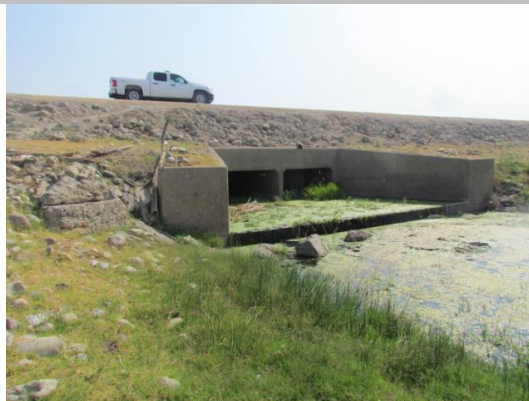
Photo 1 of 7 : ST_2014_NA0010_50_1_20140813_00008.jpg

LM Start	0.00	Rating **	N	Issue No.	1
LM End	0.00	Issue Type +	Ma	Location *	
Category	Structures & Concrete Lined Channels			GPS Latitude/Longitude	
				Start	End
Item	Photo Documentation			37.205787 °	37.205787 °
				-120.696838 °	-120.696838 °
DWR ID	DWR_NA0010_50_t_2012_1				
Action/Comments					
Inspector Comments: The structure appears to be maintained and able to perform as intended.

Looking at outlet side of structure. 2014

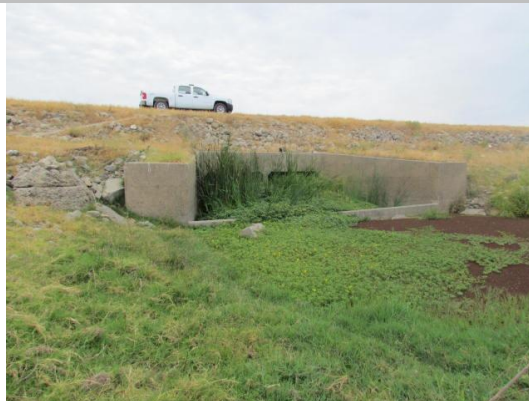
Photo 2 of 7 : ST_2014_NA0010_50_1_20140710_00001.jpg

Looking at outlet side of structure. 2013

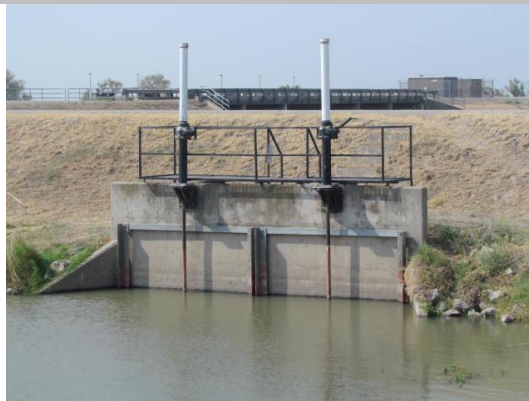
Photo 3 of 7 : ST_2014_NA0010_50_1_20140813_00006.jpg

Looking west at upstream side of sturcture. 2014

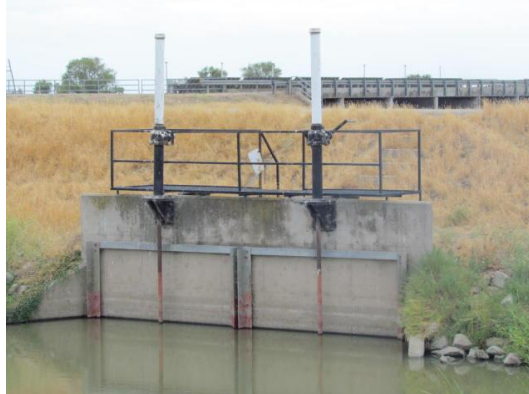
Photo 4 of 7 : ST_2014_NA0010_50_1_20140710_00002.jpg

Looking west at upstream side of structure. 2013

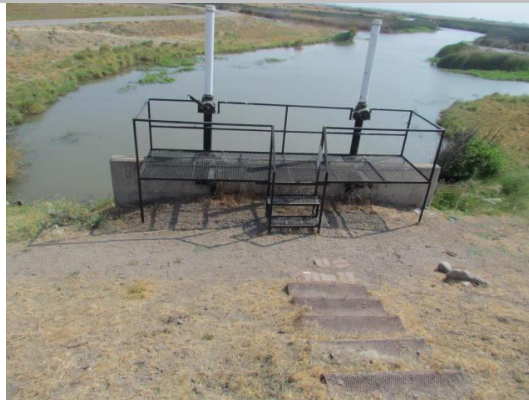
Photo 5 of 7 : ST_2014_NA0010_50_1_20140813_00007.jpg

Looking east at upstream side of structure. 2014

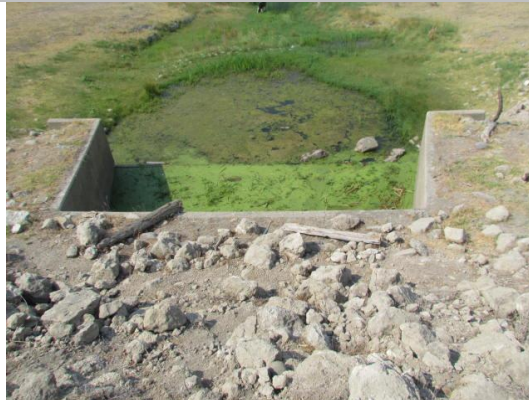
Photo 6 of 7 : ST_2014_NA0010_50_1_20140813_00010.jpg

Looking at west at downstream side of structure.

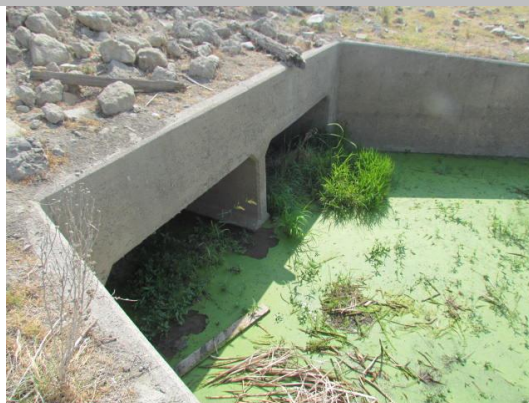
Photo 7 of 7 : ST_2014_NA0010_50_1_20140813_00009.jpg

Looking north at outlet (downstream) of structure.

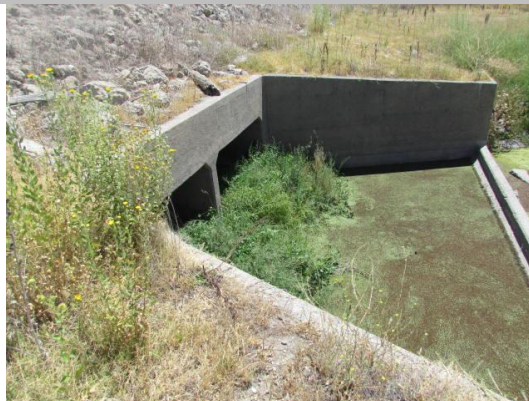
Photo 1 of 1 : ST_2014_NA0010_50_7_20140710_00003.jpg

LM Start	0.00	Rating **	A	Issue No.	7	
LM End	0.00	Issue Type +	Ma	Location *		
Category	Structures & Concrete Lined Channels			GPS Latitude/Longitude		
				Start	End	
Item	Culverts: Inlets / Outlets			37.205787 °	37.205787 °	
				-120.696838 °	-120.696838 °	
DWR ID	DWR_NA0010_50_t_2012_7					
Action/Comments						
Inspector Comments: No debris visible to block culverts.

Looking southwest at outlet of structure. (Summer 2012)

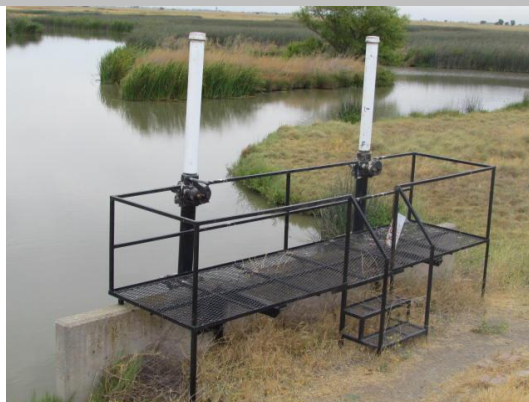
Photo 1 of 1 : ST_2014_NA0010_50_14_20140710_00004.jpg

LM Start	0.00	Rating **	A	Issue No.	14
LM End	0.00	Issue Type +	Ma	Location *	
Category	Structures & Concrete Lined Channels			GPS Latitude/Longitude	
				Start	End
Item	Manual Gate Operators			37.205787 °	37.205787 °
				-120.696838 °	-120.696838 °
DWR ID	DWR_NA0010_50_t_2012_14				
Action/Comments					
Inspector Comments: Manual gates appears to be in good working condition.

Looking east at manual gate on upstream side of structure.

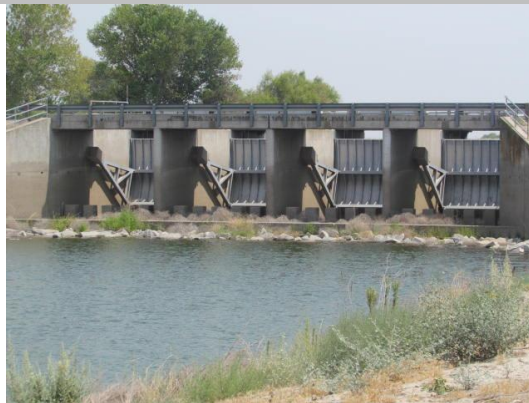
Photo 1 of 6 : ST_2014_NA0010_45_1_20140814_00014.jpg

LM Start	0.00	Rating **	N	Issue No.	1	
LM End	0.00	Issue Type +	Ma	Location *		
Category	Structures & Concrete Lined Channels			GPS Latitude/Longitude		
				Start		End
Item	Photo Documentation			36.773983 °		36.773983 °
				-120.284067 °		-120.284067 °
DWR ID	DWR_NA0010_45_t_2012_1					
Action/Comments						
Inspector Comments: The structure appears to maintained and able preformed as designed. To eliminate the vibration the gates must remain all the way open or closed.

Looking southeast at downstream side of Chowchilla Bypass Structure.

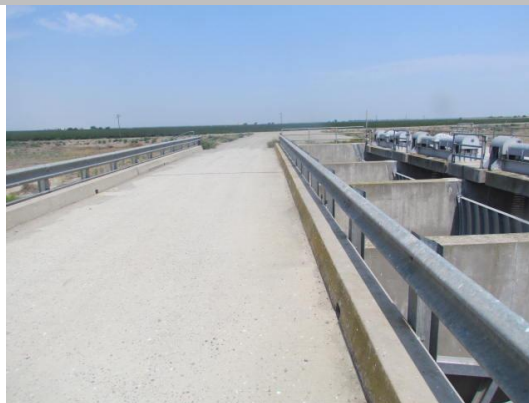
Photo 2 of 6 : ST_2014_NA0010_45_1_20140814_00015.jpg

Looking south at top of Chowchilla Bypass Structure.

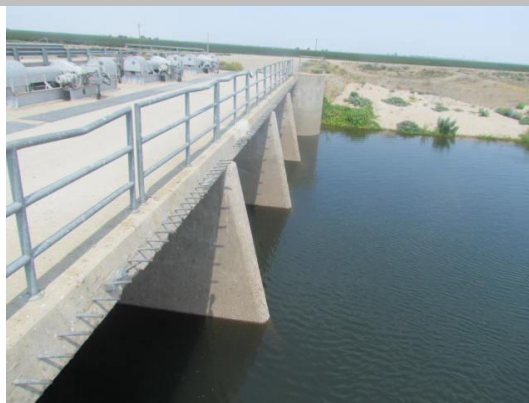
Photo 3 of 6 : ST_2014_NA0010_45_1_20140814_00016.jpg

Looking south at upstream side of Chowchilla Bypass structure.

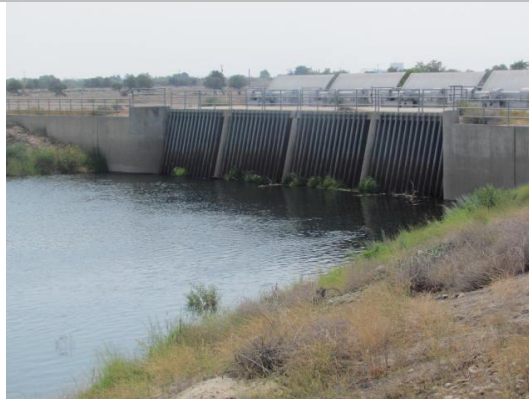
Photo 4 of 6 : ST_2014_NA0010_45_1_20140814_00017.jpg

LM Start	0.00	Rating **	N	Issue No.	1 (cont)
LM End	0.00	Issue Type +	Ma	Location *	
Category	Structures & Concrete Lined Channels			GPS Latitude/Longitude	
				Start	End
Item	Photo Documentation			36.773983 °	36.773983 °
				-120.284067 °	-120.284067 °
DWR ID	DWR_NA0010_45_t_2012_1				
Action/Comments					
Inspector Comments: The structure appears to maintained and able

Looking northwest at upstream side of San Joaquin River Structure.

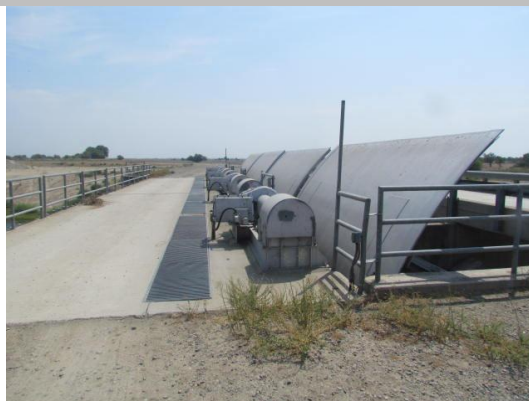
Photo 5 of 6 : ST_2014_NA0010_45_1_20140814_00018.jpg

Looking east at top of San Joaquin River structure.

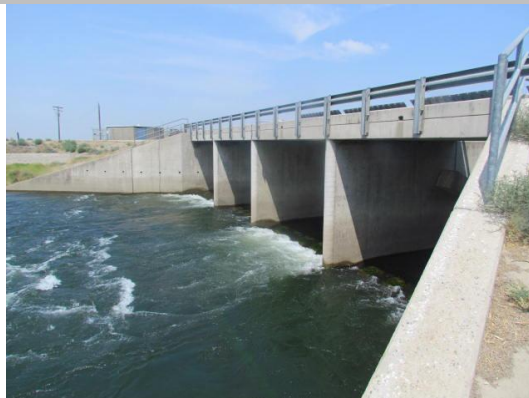
Photo 6 of 6 : ST_2014_NA0010_45_1_20140814_00019.jpg

Looking west at downstream side of San Joaquin structure.

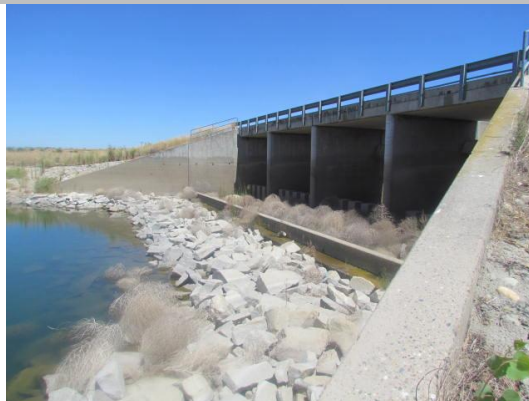
Photo 1 of 1 : ST_2014_NA0010_45_5_20140710_00007.jpg

LM Start	0.00	Rating **	A	Issue No.	5	
LM End	0.00	Issue Type +	Ma	Location *		
Category	Structures & Concrete Lined Channels			GPS Latitude/Longitude		
				Start	End	
Item	Revetments			36.773983 °	36.773983 °	
				-120.284067 °	-120.284067 °	
DWR ID	DWR_NA0010_45_t_2012_5					
Action/Comments						
Inspector Comments: All revetment appears to be properly maintained.

Looking southeast at revetment on downstream side of Chowchilla Control Structure.

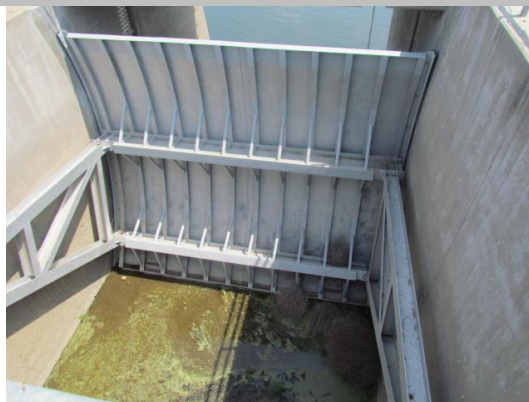
Photo 1 of 2 : ST_2014_NA0010_45_12_20140814_00020.jpg

LM Start	0.00	Rating **	A	Issue No.	12
LM End	0.00	Issue Type +	Ma	Location *	
Category	Structures & Concrete Lined Channels			GPS Latitude/Longitude	
				Start	End
Item	Sluice/Slide Gates			36.773983 °	36.773983 °
				-120.284067 °	-120.284067 °
DWR ID	DWR_NA0010_45_t_2012_12				
Action/Comments					
Inspector Comments: Gates are good operating condition.

Looking east at control gate on Chowchilla Bypass Structure.

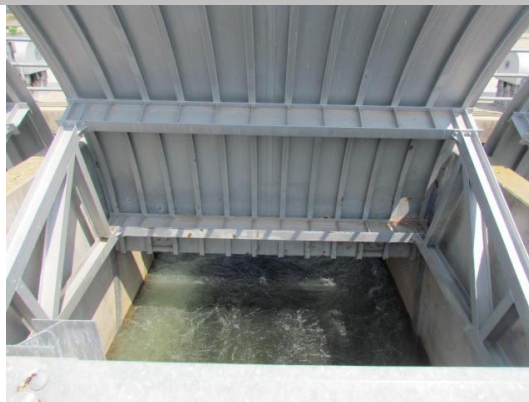
Photo 2 of 2 : ST_2014_NA0010_45_12_20140814_00024.jpg

Looking south at control gate on San Joaquin River structure.

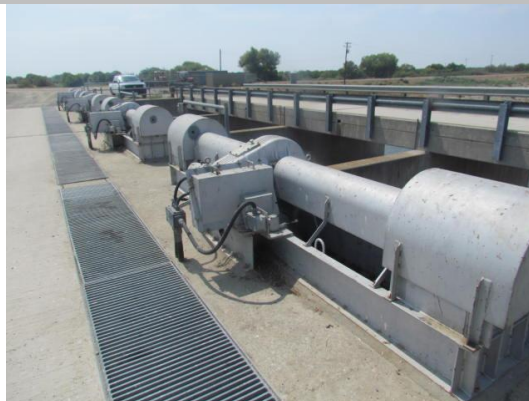
Photo 1 of 3 : ST_2014_NA0010_45_13_20140814_00021.jpg

LM Start	0.00	Rating **	A	Issue No.	13	
LM End	0.00	Issue Type +	Ma	Location *		
Category	Structures & Concrete Lined Channels			GPS Latitude/Longitude		
				Start	End	
Item	Electric Gate Operators			36.773983 °	36.773983 °	
				-120.284067 °	-120.284067 °	
DWR ID	DWR_NA0010_45_t_2012_13					
Action/Comments						
Inspector Comments: Gates appears to be in proper working condition.

Looking northwest at gate operators on Chowchilla Bypass structure.

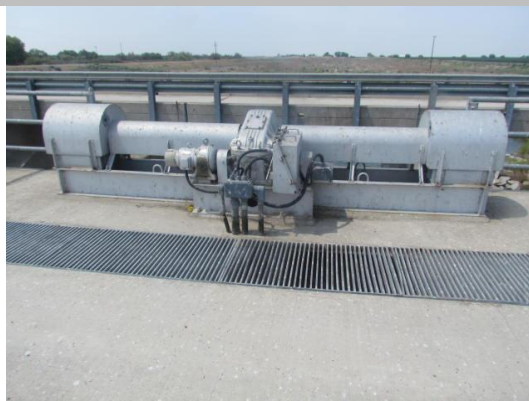
Photo 2 of 3 : ST_2014_NA0010_45_13_20140814_00022.jpg

Looking west at gate operator on Chowchilla Bypass structure.

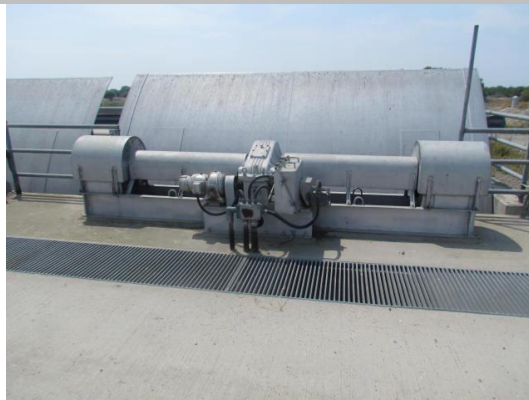
Photo 3 of 3 : ST_2014_NA0010_45_13_20140814_00023.jpg

Looking north at gate operator on San Joaquin River structure.

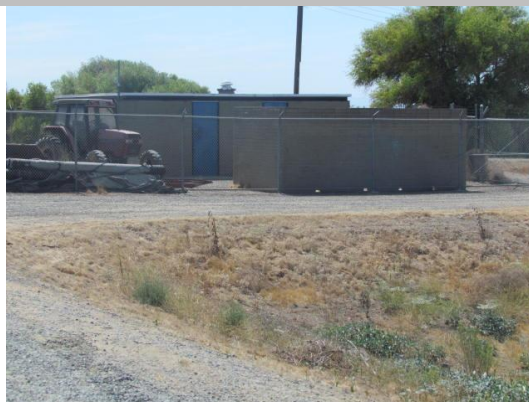
Photo 1 of 1 : ST_2014_NA0010_45_18_20140710_00013.jpg

LM Start	0.00	Rating **	A	Issue No.	18
LM End	0.00	Issue Type +	Ma	Location *	
Category	Structures & Concrete Lined Channels			GPS Latitude/Longitude	
				Start	End
Item	Security Fencing			36.773983 °	36.773983 °
				-120.284067 °	-120.284067 °
DWR ID	DWR_NA0010_45_t_2012_18				
Action/Comments					
Inspector Comments: Fencing appears to be properly maintained.

Looking north at utility shed and security fencing around structure.

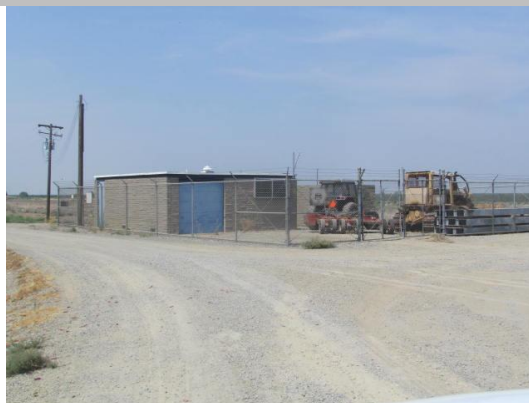
Photo 1 of 1 : ST_2014_NA0010_45_23_20140814_00025.jpg

LM Start	0.00	Rating **	A	Issue No.	23
LM End	0.00	Issue Type +	Ma	Location *	
Category	Structures & Concrete Lined Channels			GPS Latitude/Longitude	
				Start	End
Item	Safety			36.773983 °	36.773983 °
				-120.284067 °	-120.284067 °
DWR ID	DWR_NA0010_45_t_2012_23				
Action/Comments					
Inspector Comments: No safety hazards present.

Looking south at utility building.

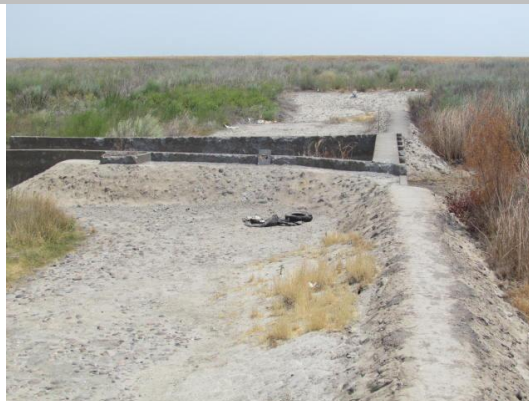
Photo 1 of 5 : ST_2014_NA0010_47_1_20140814_00011.jpg

LM Start	0.00	Rating **	N	Issue No.	1
LM End	0.00	Issue Type +	Ma	Location *	
Category	Structures & Concrete Lined Channels			GPS Latitude/Longitude	
				Start	End
Item	Photo Documentation			37.112337 °	37.112337 °
				-120.589543 °	-120.589543 °
DWR ID	DWR_NA0010_47_t_2012_1				
Action/Comments					
Inspector Comments: San Joaquin structure has some minor structure damage. The Sand Slough structure appears to be maintained and able to function as designed.

Looking south at overview of structure.

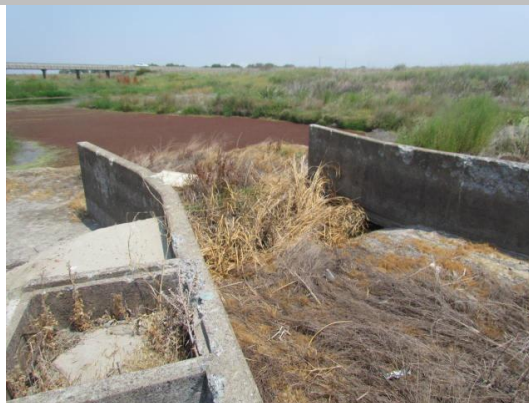
Photo 2 of 5 : ST_2014_NA0010_47_1_20140814_00012.jpg

Looking west at downstream side of structure.

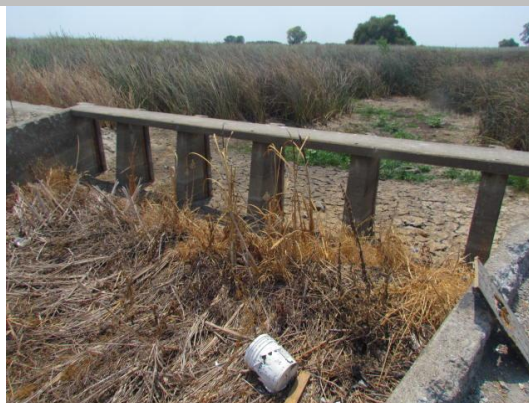
Photo 3 of 5 : ST_2014_NA0010_47_1_20140814_00013.jpg

Looking east at upstream side of structure.

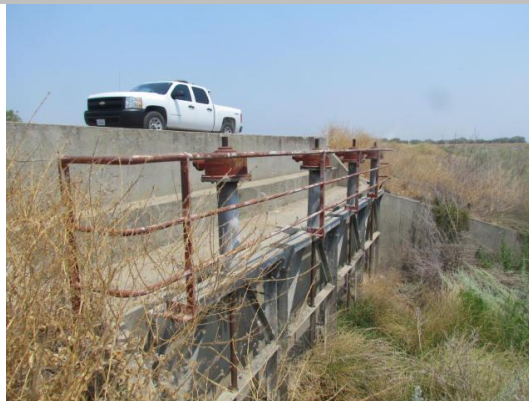
Photo 4 of 5 : ST_2014_NA0010_47_1_20140814_00014.jpg

LM Start	0.00	Rating **	N	Issue No.	1 (cont)	
LM End	0.00	Issue Type +	Ma	Location *		
Category	Structures & Concrete Lined Channels			GPS Latitude/Longitude		
				Start	End	
Item	Photo Documentation			37.112337 °	37.112337 °	
				-120.589543 °	-120.589543 °	
DWR ID	DWR_NA0010_47_t_2012_1					
Action/Comments						
Inspector Comments: San Joaquin structure has some minor structure

Looking at downstream side of Sand Slough structure.

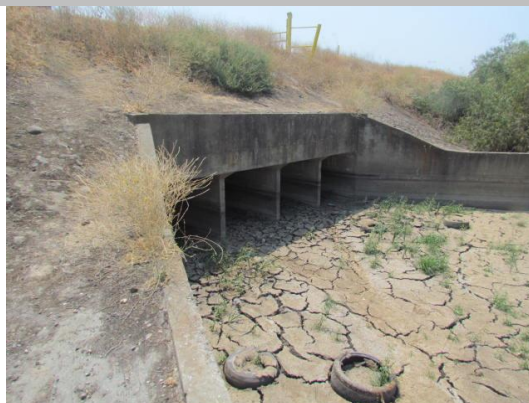
Photo 5 of 5 : ST_2014_NA0010_47_1_20140814_00015.jpg

Looking west at upstream side of Sand Slough structure.

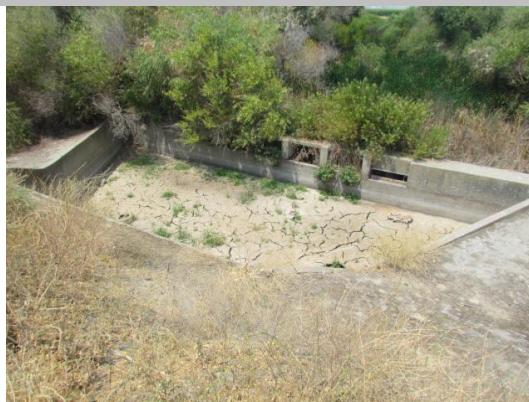
Photo 1 of 1 : ST_2014_NA0010_47_7_20140814_00016.jpg

LM Start	0.00	Rating **	A	Issue No.	7
LM End	0.00	Issue Type +	Ma	Location *	
Category	Structures & Concrete Lined Channels			GPS Latitude/Longitude	
				Start	End
Item	Culverts: Inlets / Outlets			37.112337 °	37.112337 °
				-120.589543 °	-120.589543 °
DWR ID	DWR_NA0010_47_t_2012_7				
Action/Comments					
Inspector Comments: There is minor vegetation in inlet culvert.

Looking south at inlet side of Sand Slough structure.

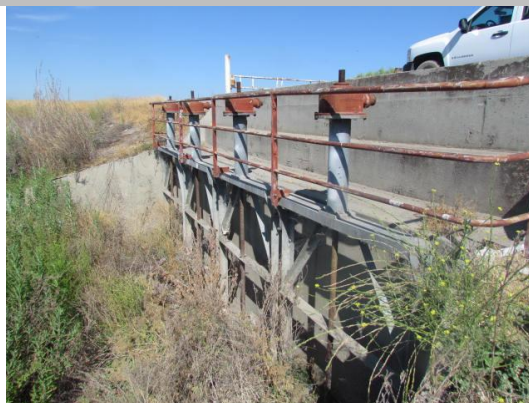
Photo 1 of 2 : ST_2014_NA0010_47_12_20140710_00006.jpg

LM Start	0.00	Rating **	A	Issue No.	12
LM End	0.00	Issue Type +	Ma	Location *	
Category	Structures & Concrete Lined Channels			GPS Latitude/Longitude	
				Start	End
Item	Sluice/Slide Gates			37.112337 °	37.112337 °
				-120.589543 °	-120.589543 °
DWR ID	DWR_NA0010_47_t_2012_12				
Action/Comments					
Inspector Comments: Gates appear to be in good working condition. Medium sediment & vegetation in front of gates.

Looking northeast at downstream side of structure.

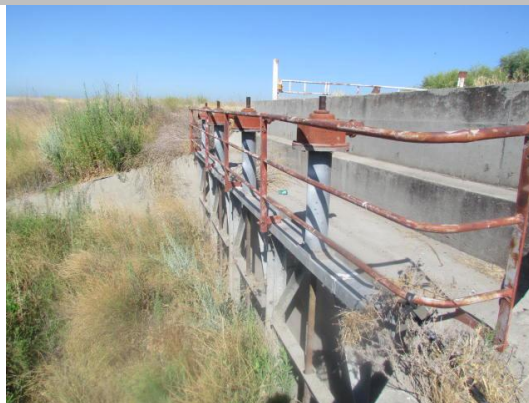
Photo 2 of 2 : ST_2014_NA0010_47_12_20140710_00007.jpg

Looking east at gates on downstream side of Sand Slough structure.,

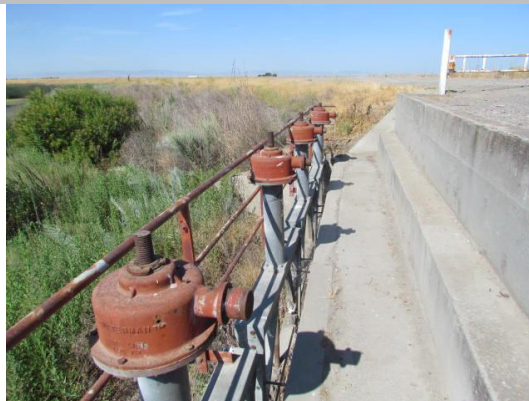
Photo 1 of 1 : ST_2014_NA0010_47_14_20140710_00008.jpg

LM Start	0.00	Rating **	M	Issue No.	14
LM End	0.00	Issue Type +	Ma	Location *	
Category	Structures & Concrete Lined Channels	GPS Latitude/Longitude			
		Start	End		
Item	Manual Gate Operators	37.112337 °	37.112337 °		
		-120.589543 °	-120.589543 °		
DWR ID	DWR_NA0010_47_t_2012_14				
Action/Comments					
Inspector Comments: All manual gates appears to be in proper working condition. District caps off manual operation stem to secure gates.Sediment appears to effect function of gates.

Looking southeast at manual gate operators on upstream side of structure.
